WL-TR-96-4015

CERAMIC BEARING DEVELOPMENT

VOL 1, FATIGUE AND WEAR BEHAVIOR OF NBD-200
SILICON NITRIDE BALLS

INTERIM REPORT FOR 08/01/92-10/01/94

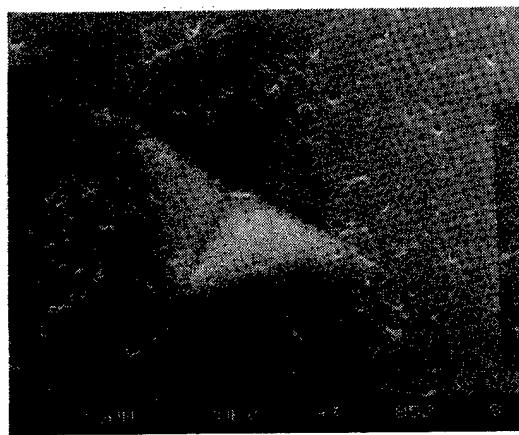
Figure 13 Artificial Flaws Produced With Vickers Diamond Indentor: (a) 5.0 Kg Indent Load, Average Crack Length 172 μm , (b) 1.0 Kg Indent Load, Average Crack Length 61 μm (c) 0.5 Kg Indent Load, Average Crack Length 34 μm , (d) Typical "Natural" Flaws On Ball Surface.

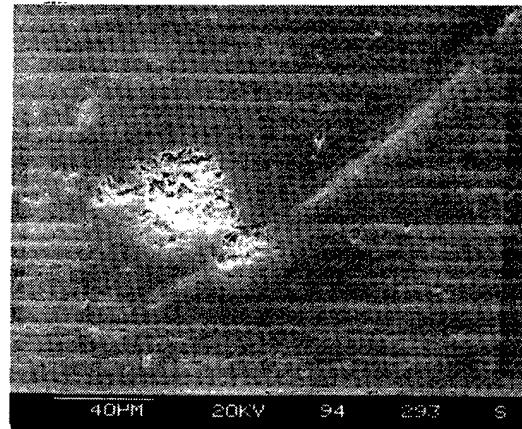
Figures 48 and 49 illustrate the post-test appearance of the outer and inner races, respectively. The outer race shows numerous micropits, on the order of 10-15 μm in diameter. A large amount of debris damage from the micropitting, in the form of pitting, dents and apparent polishing-type wear was present. The inner race showed less damage from the circulated debris, but more fatigue micropitting than the outer race. The origins of the fatigue spalling were identified in several instances as alloy carbides (Mo, Cr, Fe) from remnant particles within the spalls. Figure 49d, however, shows a large carbide of this type on the surface within close proximity to a micropit which apparently originated at a cluster of alumina particles instead of at the carbide.

Figure 49 Post-Test Condition of M-50 Steel Inner Races and Bearing B3 Run 830 Hrs., at 2.61 GPa (379 ksi), $\lambda = 0.3$: (a) General Face Appearance, (b) Micropitting and Debris Gouge, (c) Micropitting And Debris Damage, (d) Micropitting And Debris Damage, Large Carbide At "A".

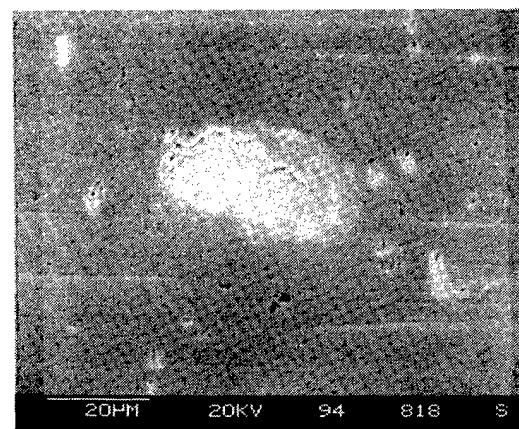
Figures 55 and 56 show, respectively, the post-test appearance of the outer and inner races. Both are marked by numerous microspalls. Note that the race finishes, away from

the spalls, appear much smoother in the all-steel bearing than those in the hybrid bearing illustrated in Figures 48 and 49. The reason for this is not clear. It could be related to some mutual plastic accommodation of the ball and race surfaces or, simply to a greater degree of polishing due to more debris passing through the all-steel bearing in the presence of a greater number of microspalls. At any rate, the effect is minor, in terms of the volume of material removed, compared to that associated with the microspalling.

Figure 56 Post-Test Appearance Of Inner Race Of All-Steel Bearing M-50-X1 Run 500 Hrs. At 2.27 GPa (329 ksi)
 $\lambda = 0.3$ (a) General Appearance (b,c,d)
Microspalling.
